NDE METHOD FOR CHARACTERIZING ANODIZED A1 SURFACES

ROCKWELL INTERNATIONAL SCIENCE CENTER
1049 CAMINO DOS RIOS
THOUSAND OAKS, CALIFORNIA 91360

TECHNICAL REPORT AFML-TR-78-146
Final Report for period 1 September 1977 through 31 July 1978

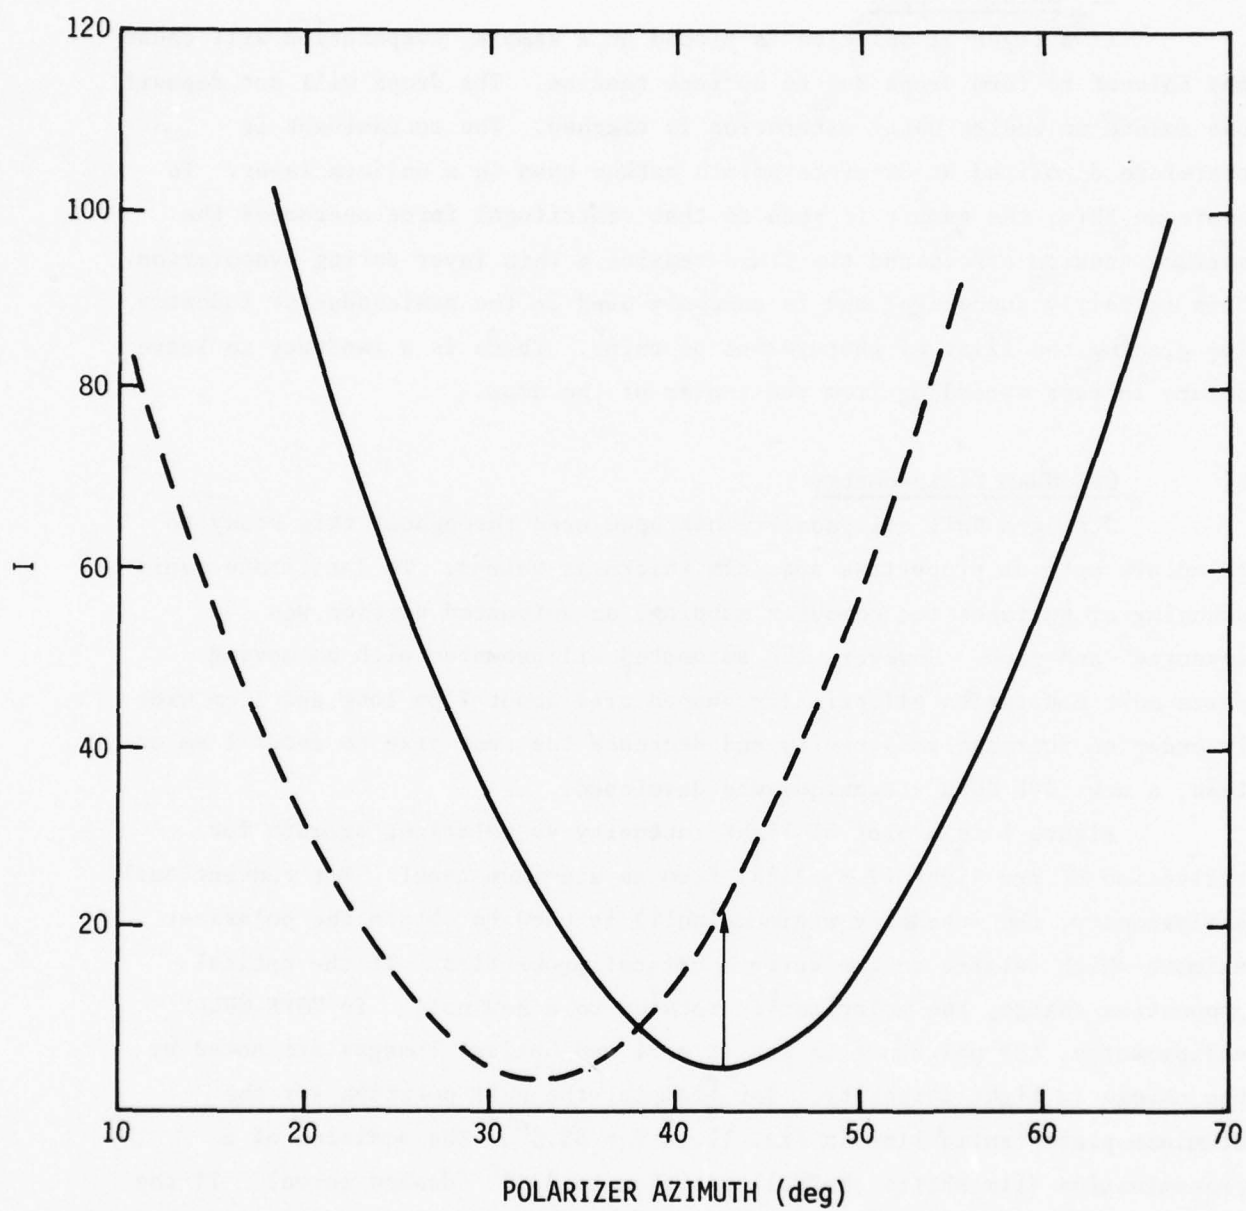
Fig. 1 Light intensity, I , vs polarizer asimuth.

Figure 1 is a plot of light intensity vs polarizer azimuth for reflection of red light ($\lambda = 6328\text{\AA}$) from an aluminum panel. For conventional ellipsometry, the intensity minimum (null) is used to obtain the polarizer azimuth which relates to the surface optical properties. If the optical properties change, the polarizer is rotated to a new null. In "OFF NULL" ellipsometry, the polarizer is set at null and optical changes are noted by the change in light intensity. For example, the null position for the aluminum plate (solid line in Fig. 1) is $P = 43.5^\circ$. The addition of a contamination film shifts the null position to 33.5° (dashed curve). If the polarizer is left at 43.5° , the light intensity follows the arrow from $I = 4$ to $I = 22$.

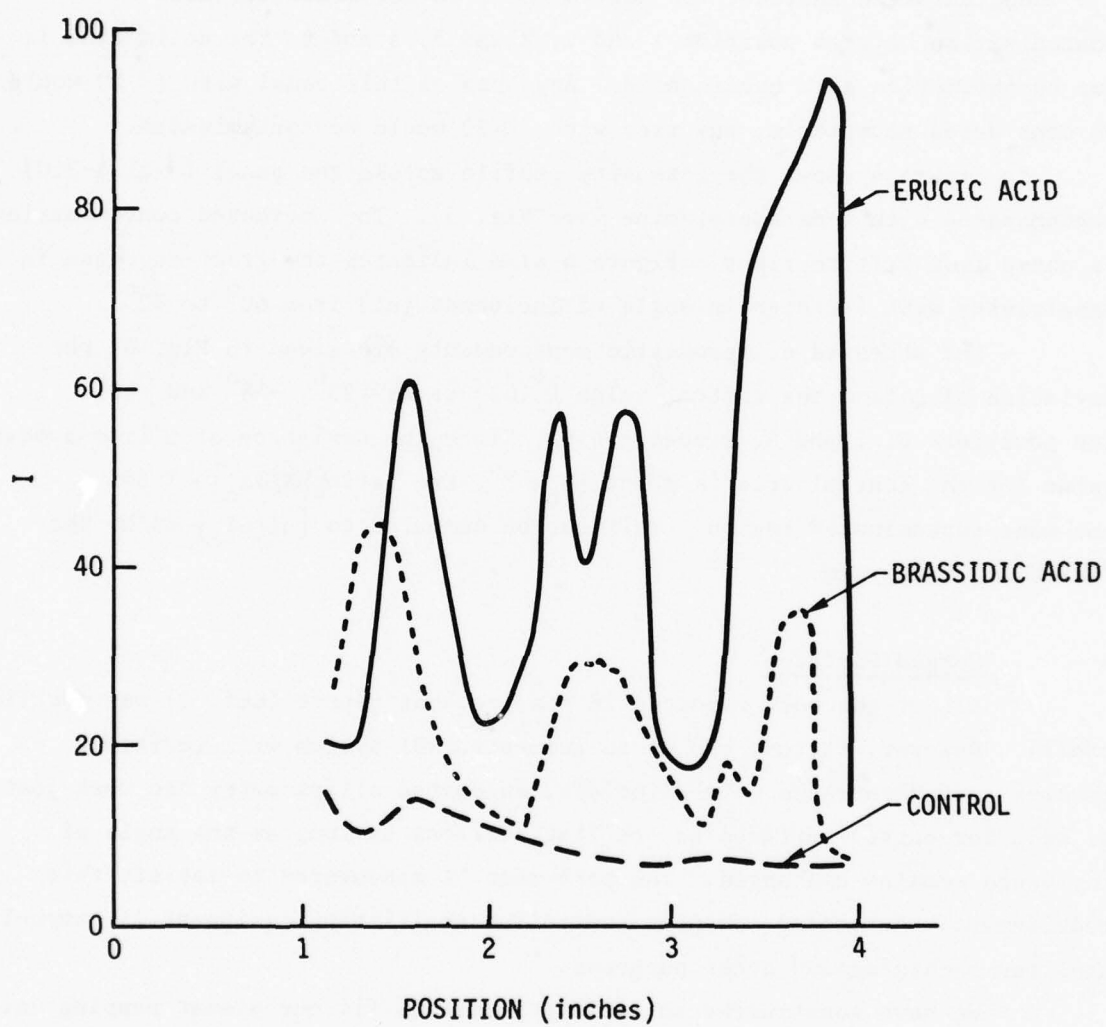
Fig. 2 Intensity vs position for contamination on
A1 panel 3-27-7-76. (see Fig. 3)

geometrical area or for rapid following of changes with time. To illustrate the sensitivity, Fig. 2 shows plots of I vs position (1 to 4 inches) on the phosphoric acid analyzed panel 3-28-7-76, Fig. 3 (see last year's report Fig. C25a AFML-TR-77-42). The lower dashed curve is the intensity profile for the uncontaminated surface, the dotted curve is for brassidic acid contamination between position 1 and 2, 2 and 3, 3 and 4, the solid line is for contamination with erucic acid. Any area of this panel with $I < 20$ would be considered acceptable, any area with $I > 20$ would be contaminated.

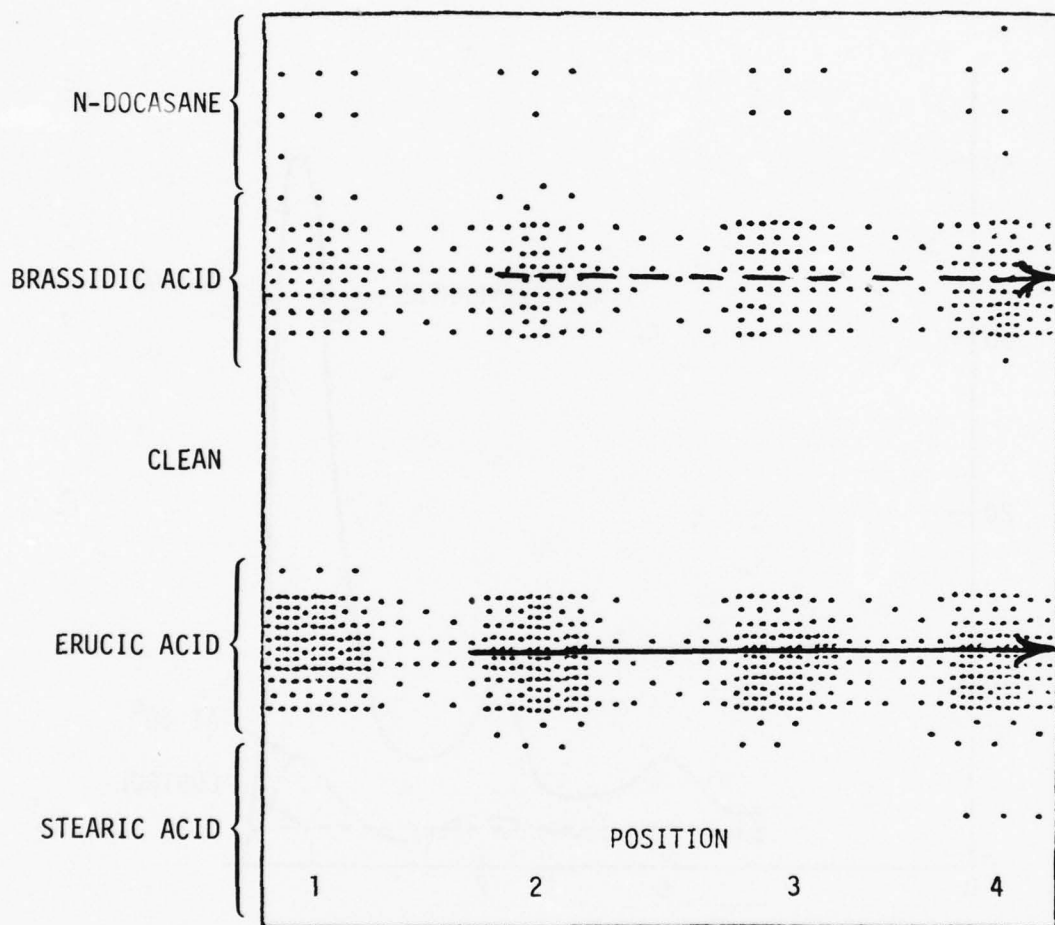
Fig. 3 A Δ plot ($165 < \Delta < 163$) for a panel that was contaminated in four regions but left clean in the center region.

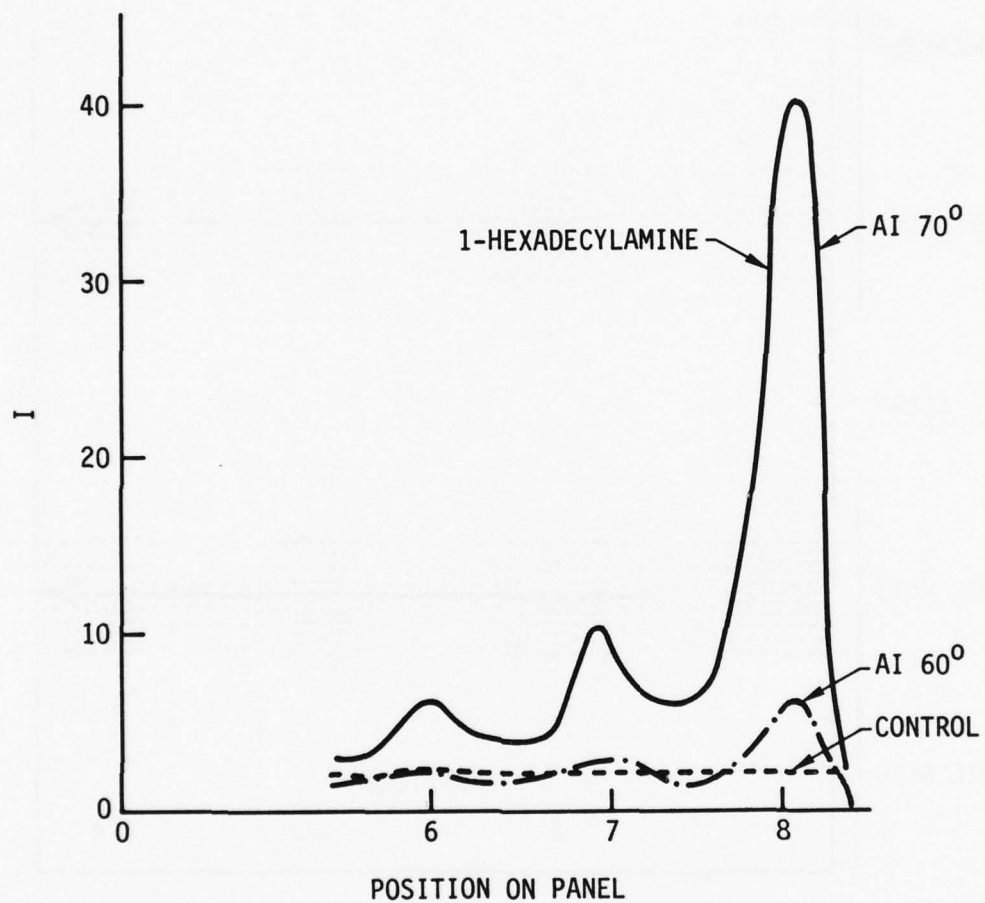
Fig. 4 Plot of I vs position on Al panel contaminated with 1-Hexadecylamine. (see Fig. 5)

Figure 4 shows the intensity profile across the panel (6-21-4-76C) contaminated with 1-Hexadecylamine (see Fig. 5). The increased contamination is noted from left to right. Figure 4 also indicates the great increase in sensitivity with increase in angle of incidence (AI) from 60° to 70° .

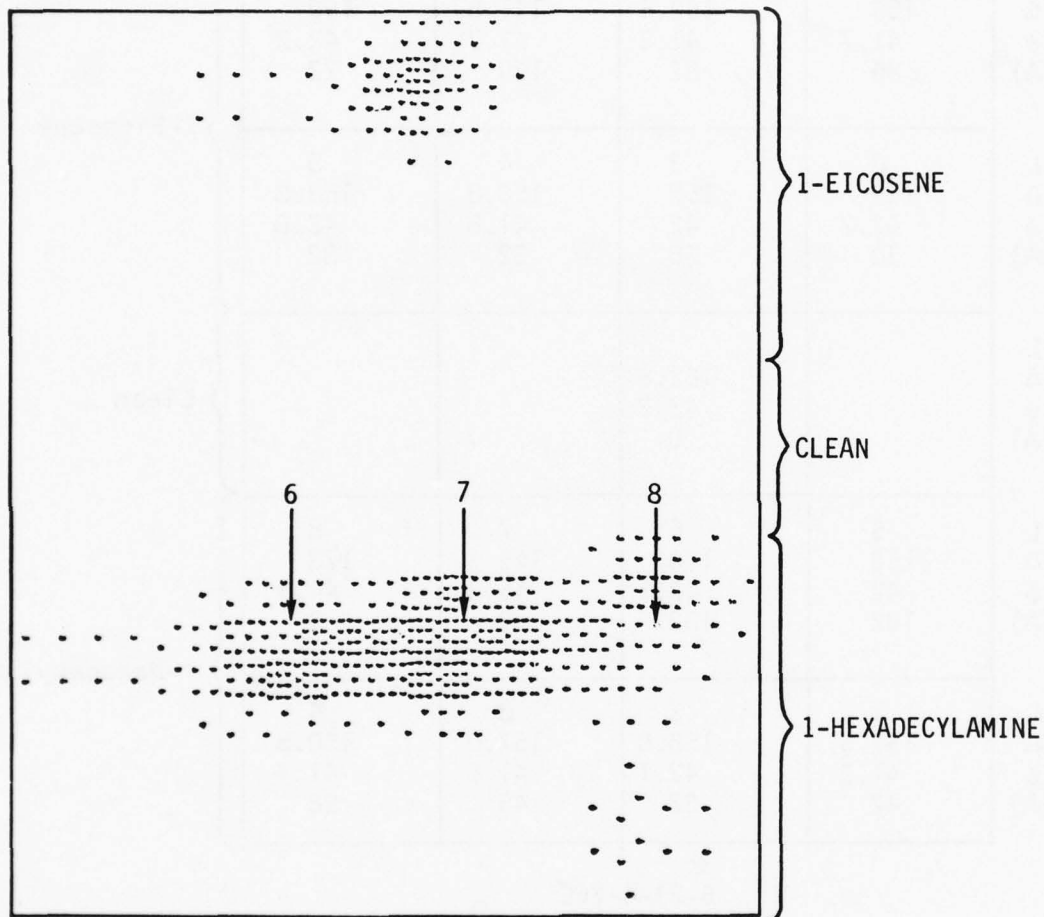
Fig. 5 Computer plot of $162 < \Delta < 160$ for contamination.
Top: 1-Eicosene; Middle: Clean; Bottom 1-Hexadecylamine.

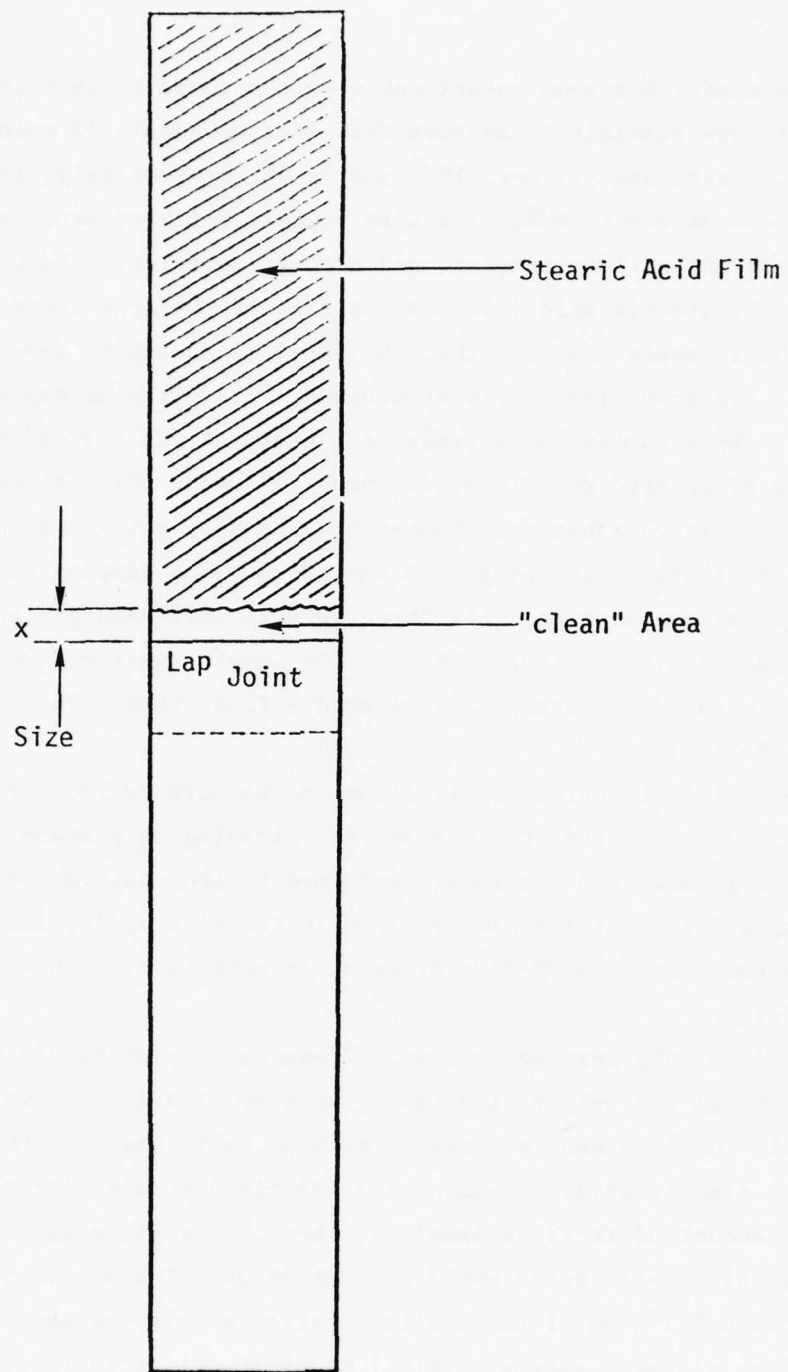
Fig. 8 Diagram of depleted contamination after curing.

The seven contaminated specimens were mated to clean specimens using FM-73 as the adhesive. The samples, including a control, were then cured in the usual manner. After curing, it was noted that the stearic acid films were depleted in the region just next to the lap joint (see Fig. 8). The area

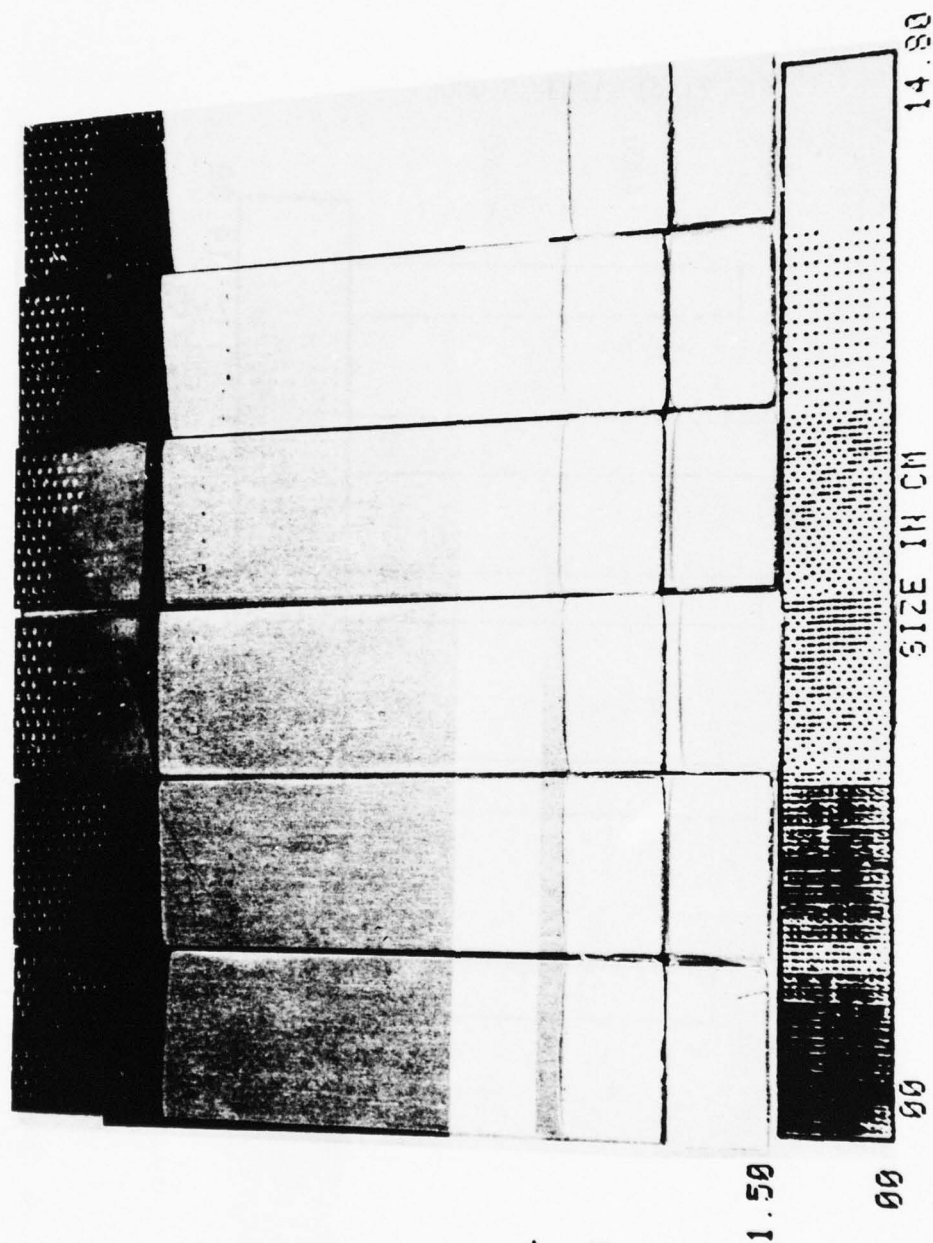
Fig. 9 Computer map of contamination on the lower half inch of lap shear specimens.

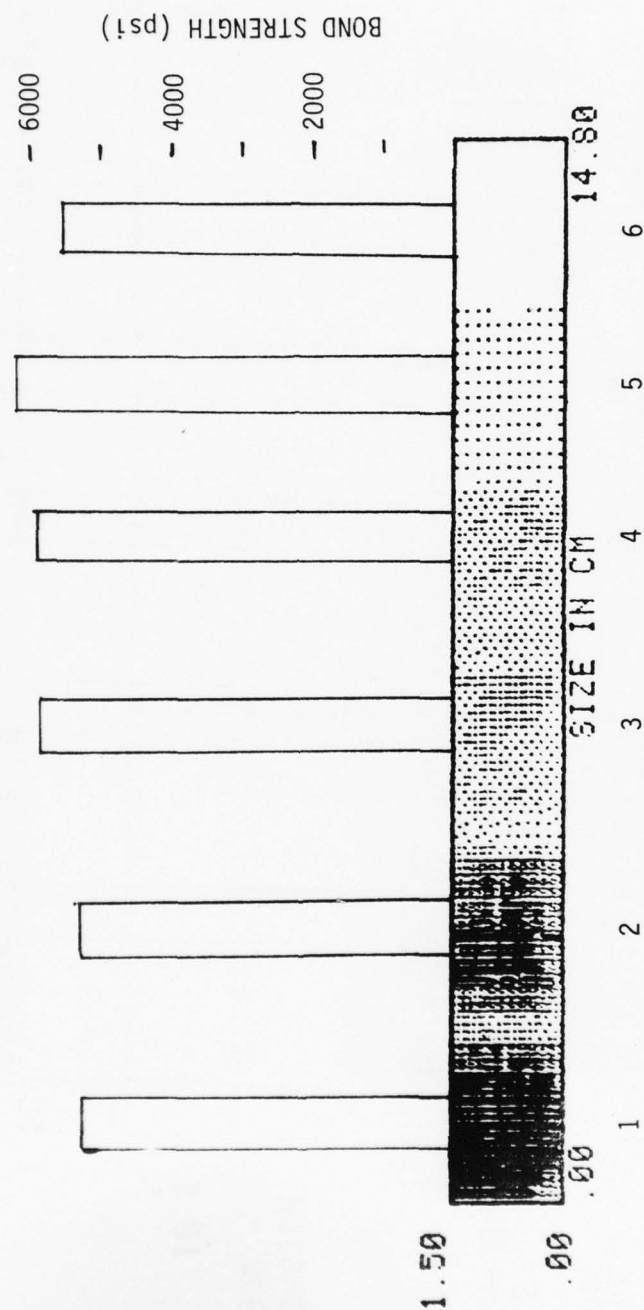
Fig. 10 Computer contamination plot for cotton glove smudge on PAA A1 7075-T6.
Bars indicate relative lap shear strength.

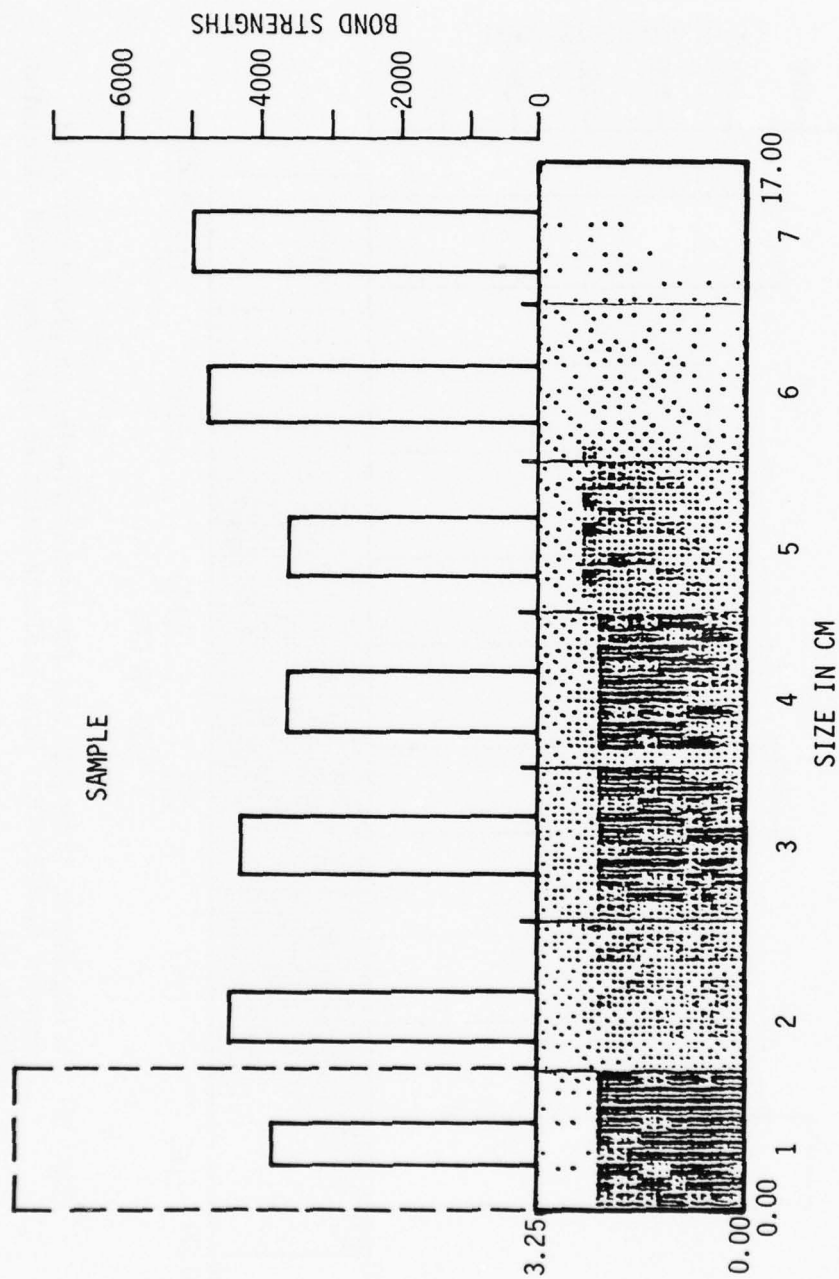
Fig. 11 Computer contamination plot for stearic acid on FPL etched Al 7075-T6.
Bars indicate relative lap shear bond strengths. (Table 26)

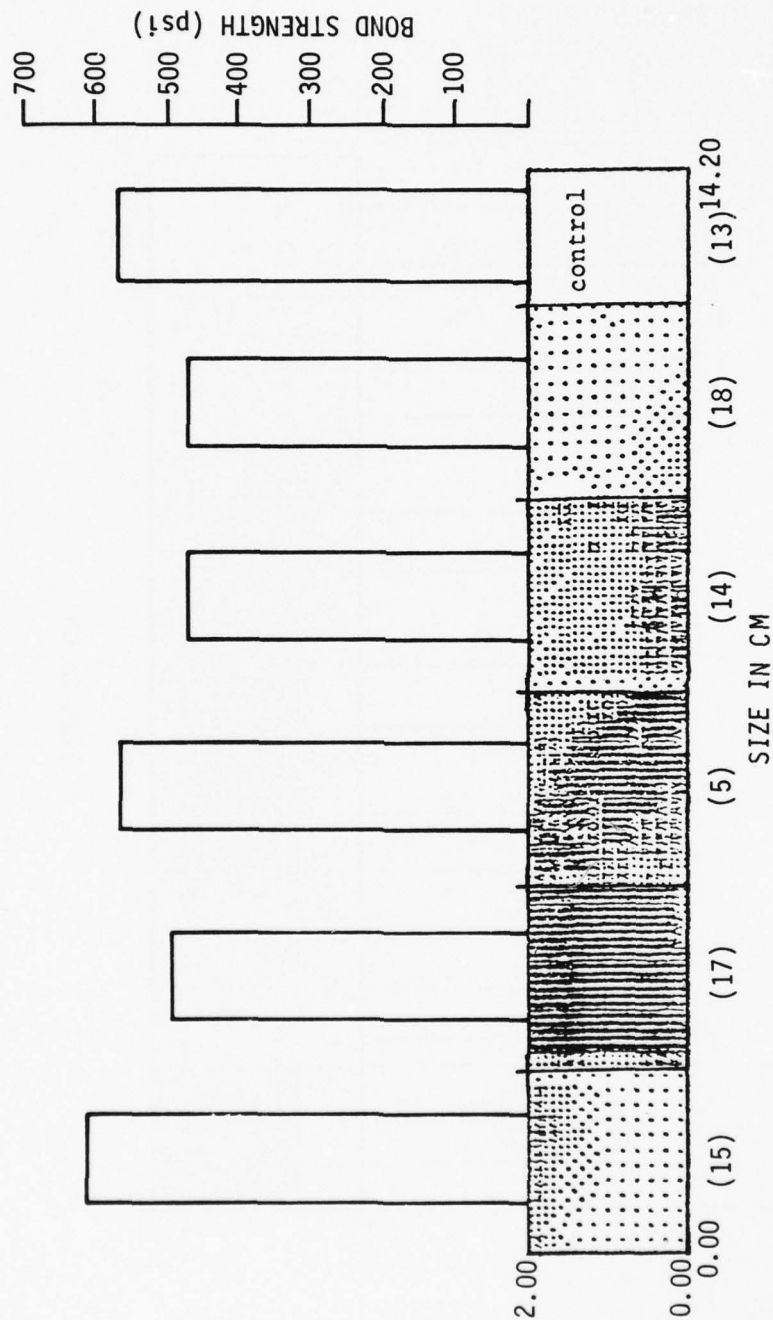
Fig. 12 Ellipsometric intensity map for hexadecylamine on phosphoric acid anodized Al 7075-T6. Bars indicate relative lap shear bond strengths. (Table 16)

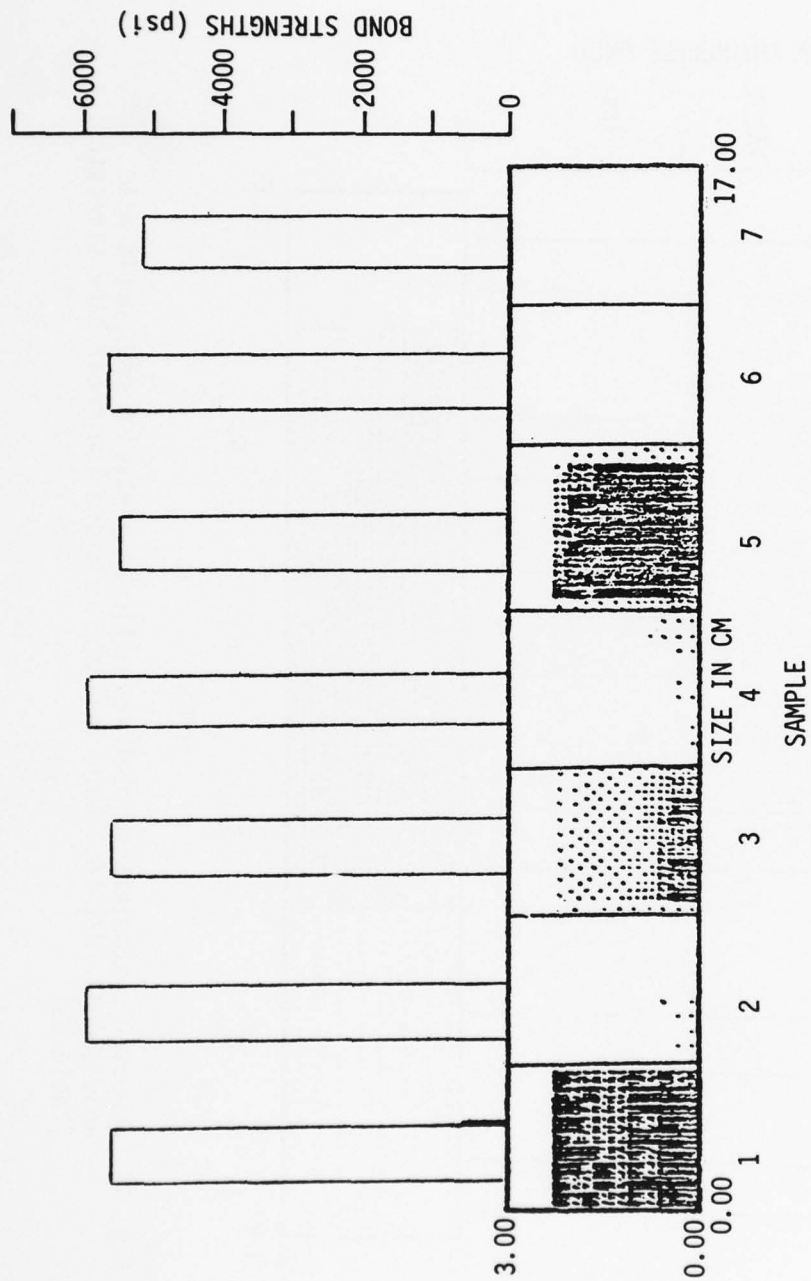
Fig. 13 Computer contamination plot for lub oil on anodic Al 7075-T6.
Bars indicate relative lap shear strengths. (Table 20)

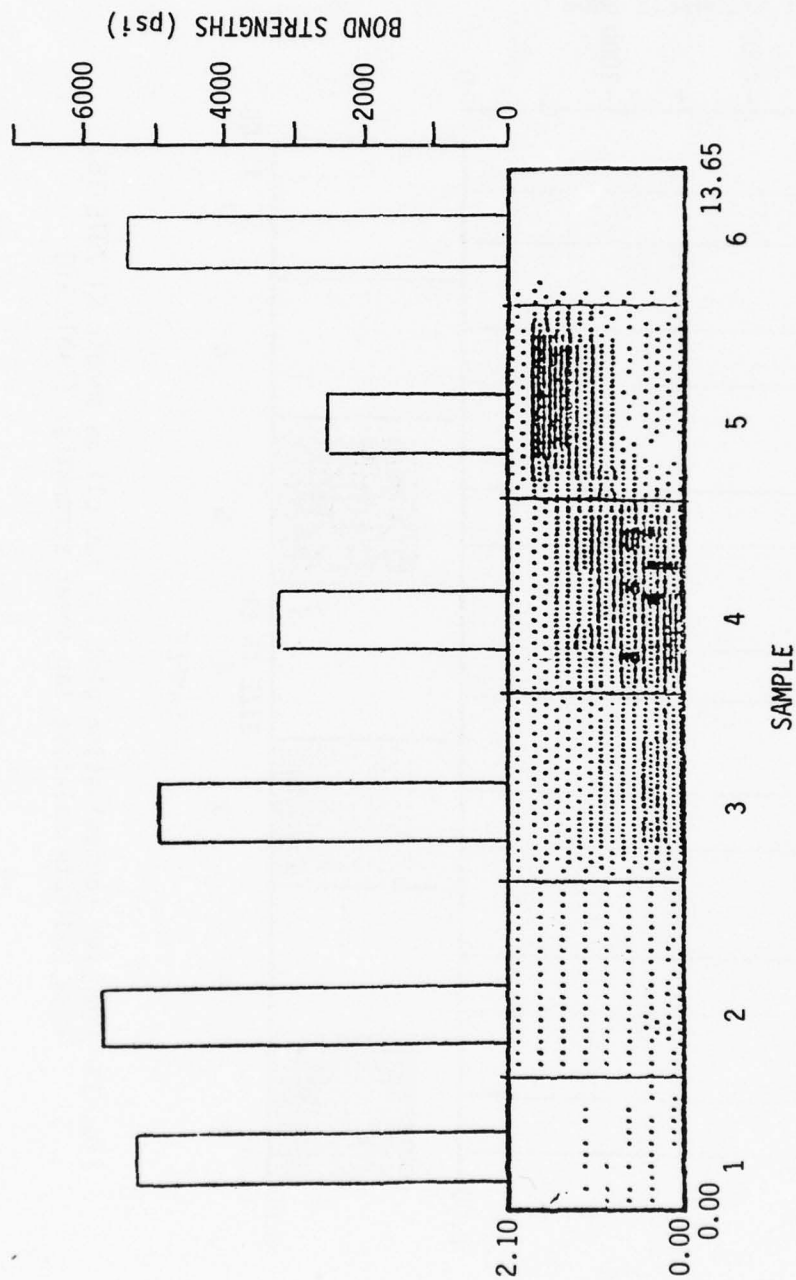
Fig. 14 Computer contamination plot for silicone grease on phosphoric acid anodized Al 7075-T6. Bars indicate relative lap shear bond strengths. (Table 23)

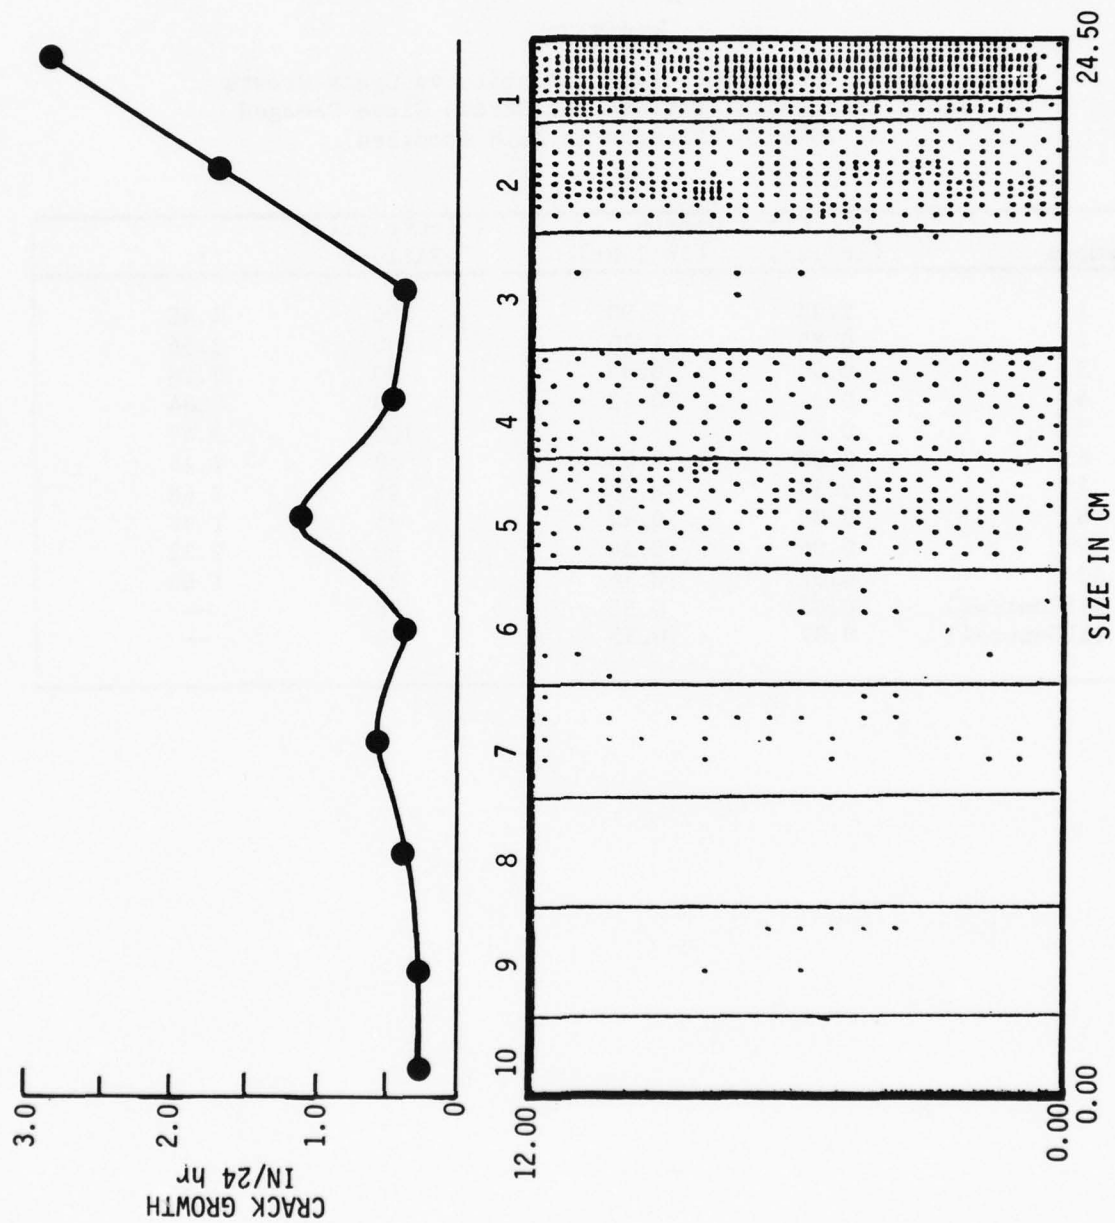
Fig. 15 Ellipsometric intensity map for cotton glove damaged A1 7075-T6 (phosphoric acid anodized).

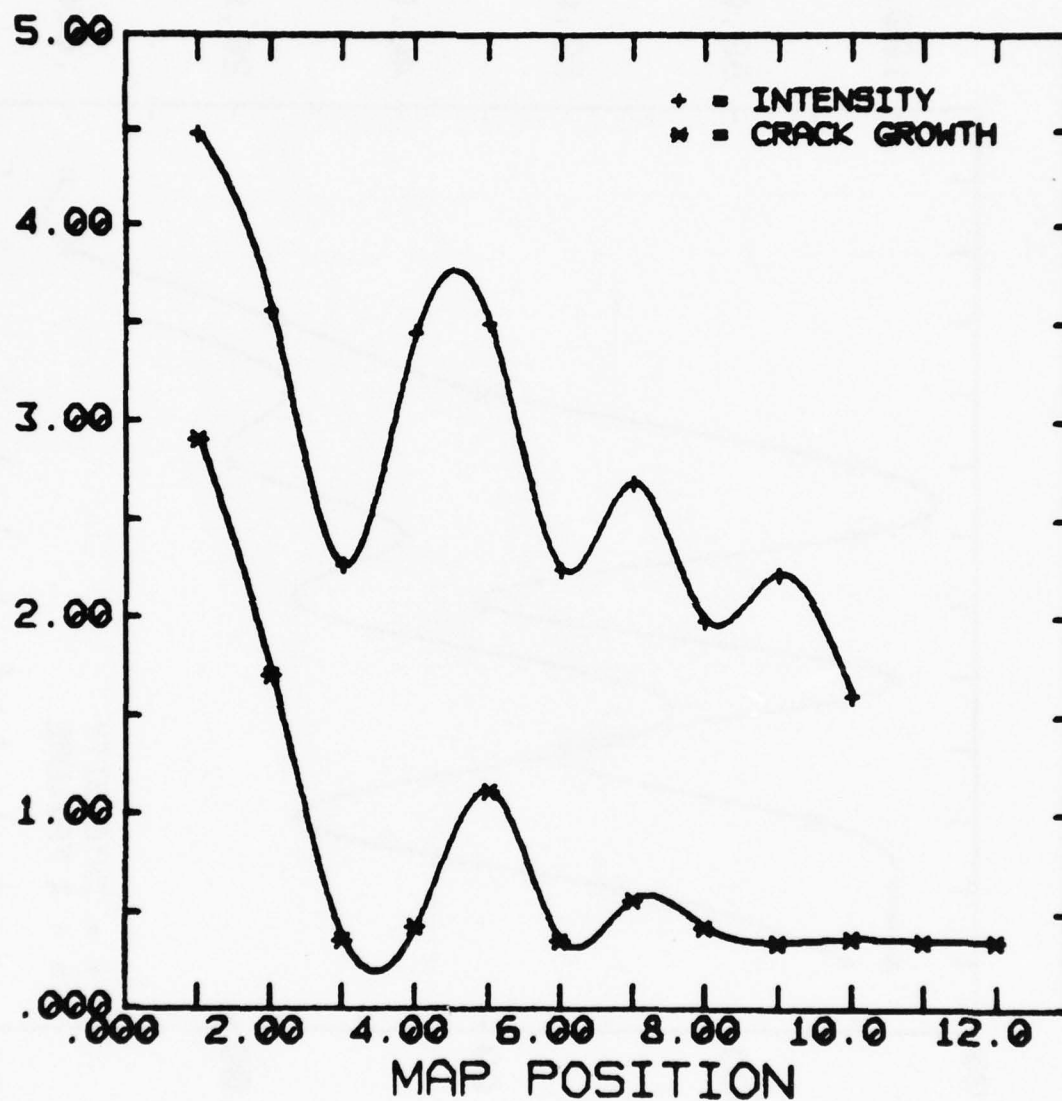
Fig. 16 Correlation between ellipsometric and failure maps.

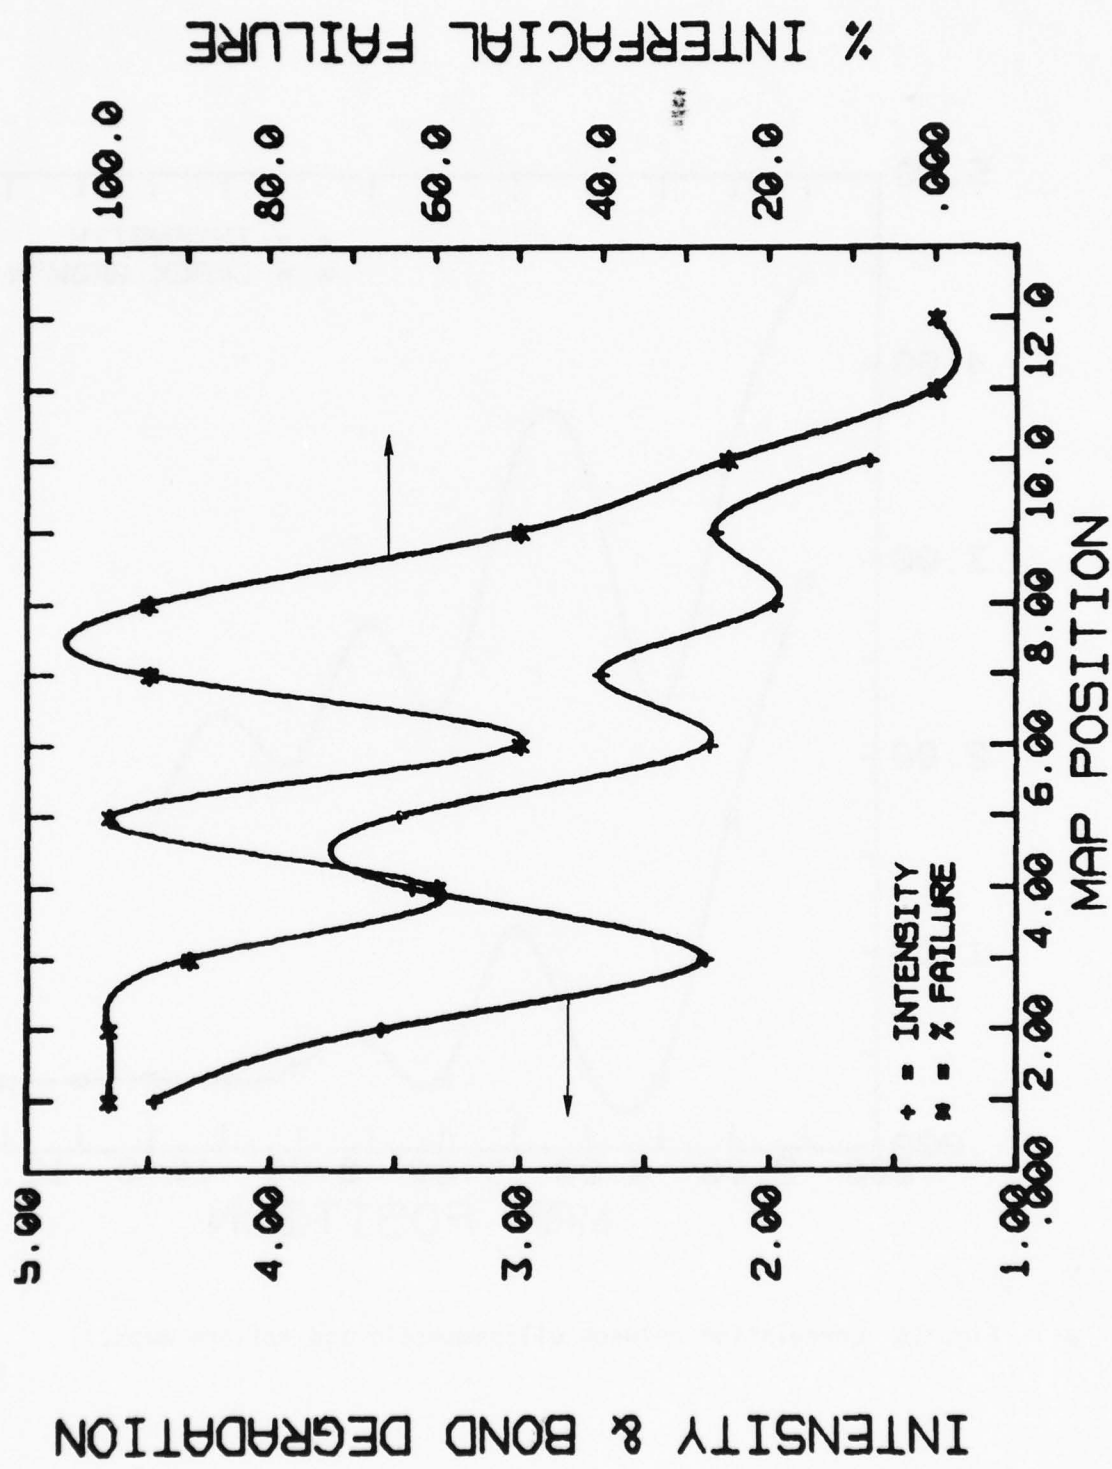
Fig. 17 Correlation between ellipsometric and failure maps.

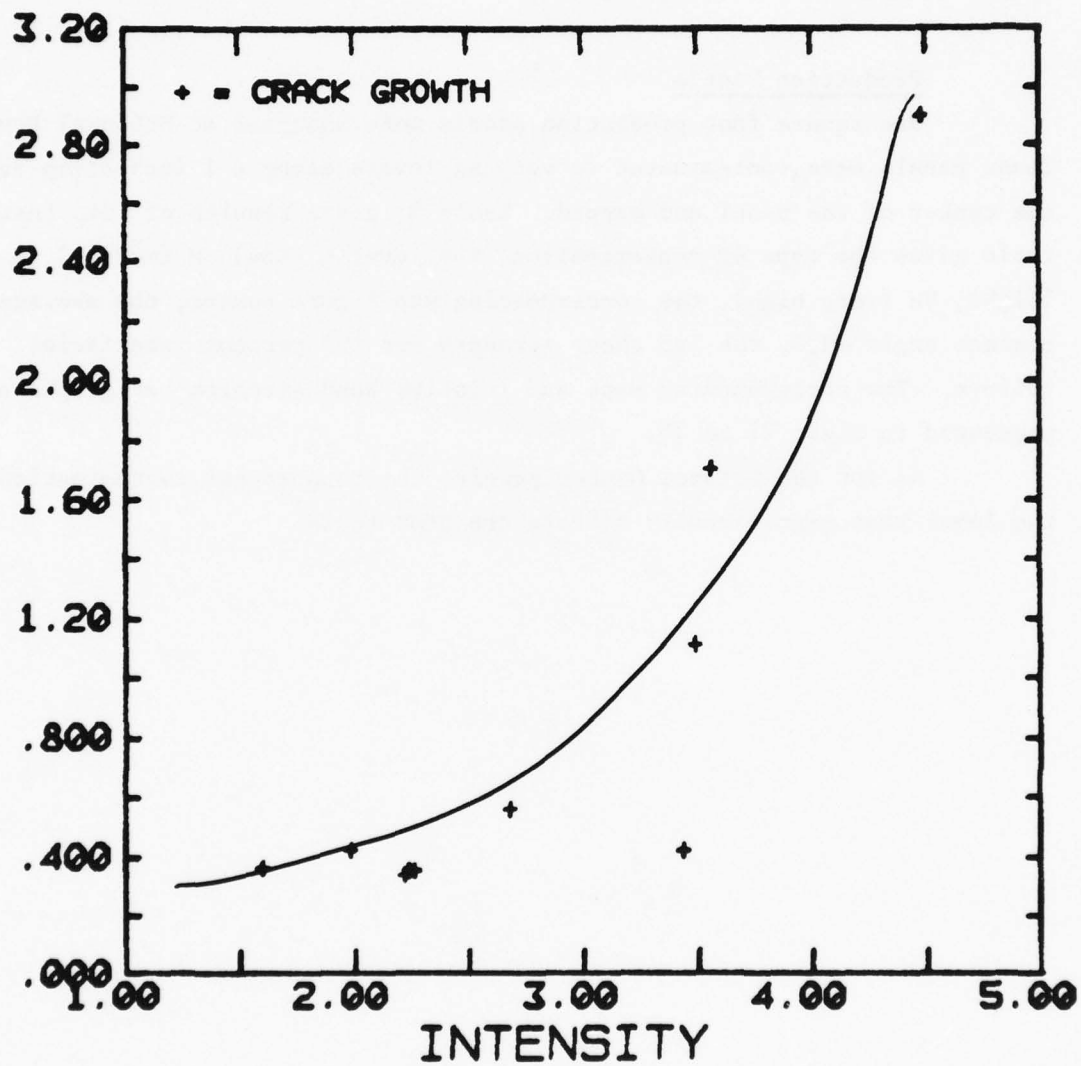
Fig. 18 Correlation between ellipsometric and failure maps.

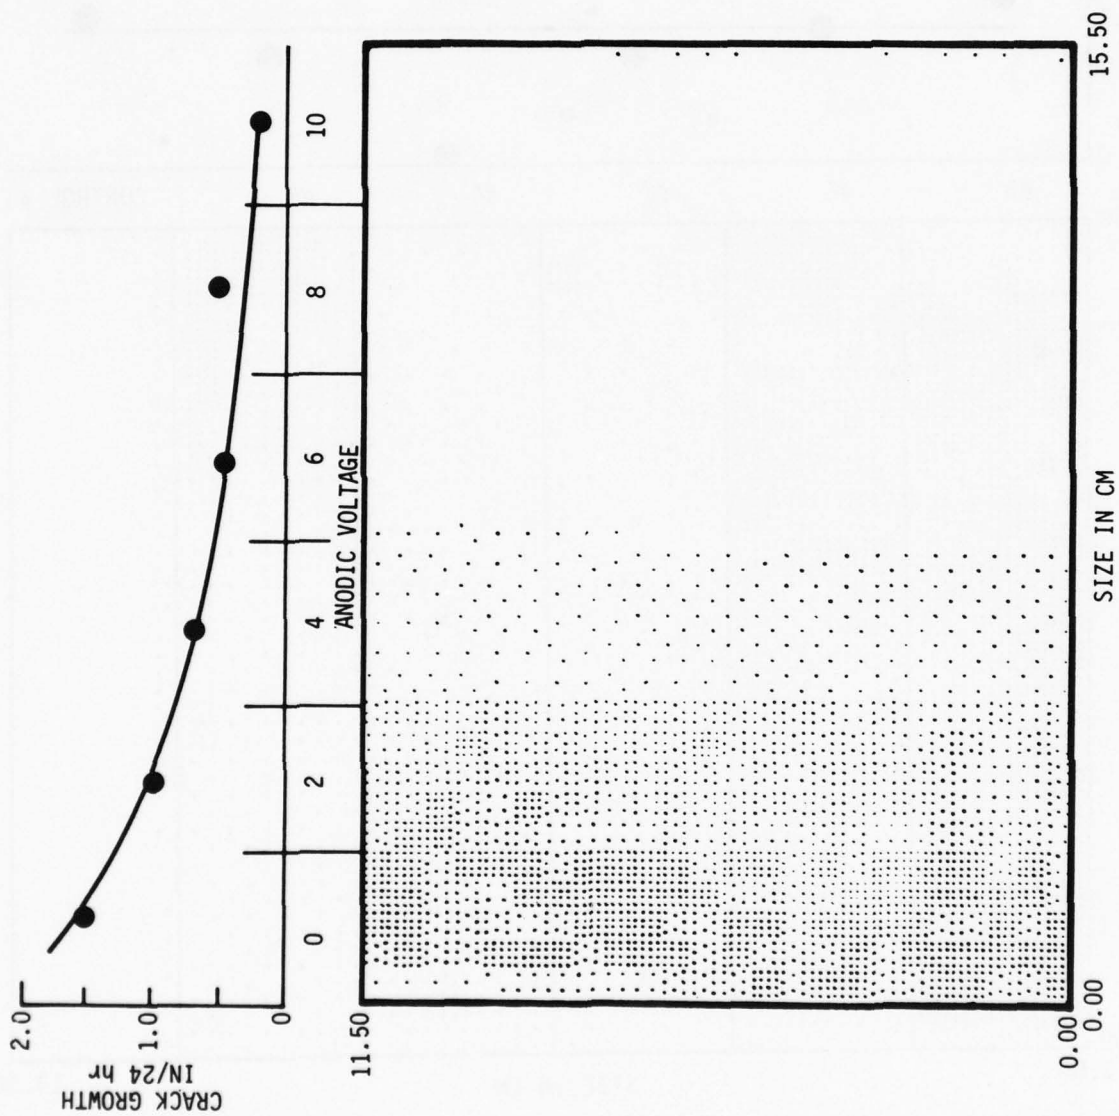
Fig. 19 Computer map for wedge specimens anodized at various voltages and corresponding crack extension curve from Table 10.

Figure 19 is a map of wedge test samples that were anodized at various potentials to simulate a possible process error. There is a serious degradation in bond durability below 4 volts ($<1000\text{\AA}$) and this is very distinctly revealed by the computer map. Figure 20 is a similar map for oil contamination. As observed for lap shear tests, oil is easily mapped, but has little effect on bond durability.

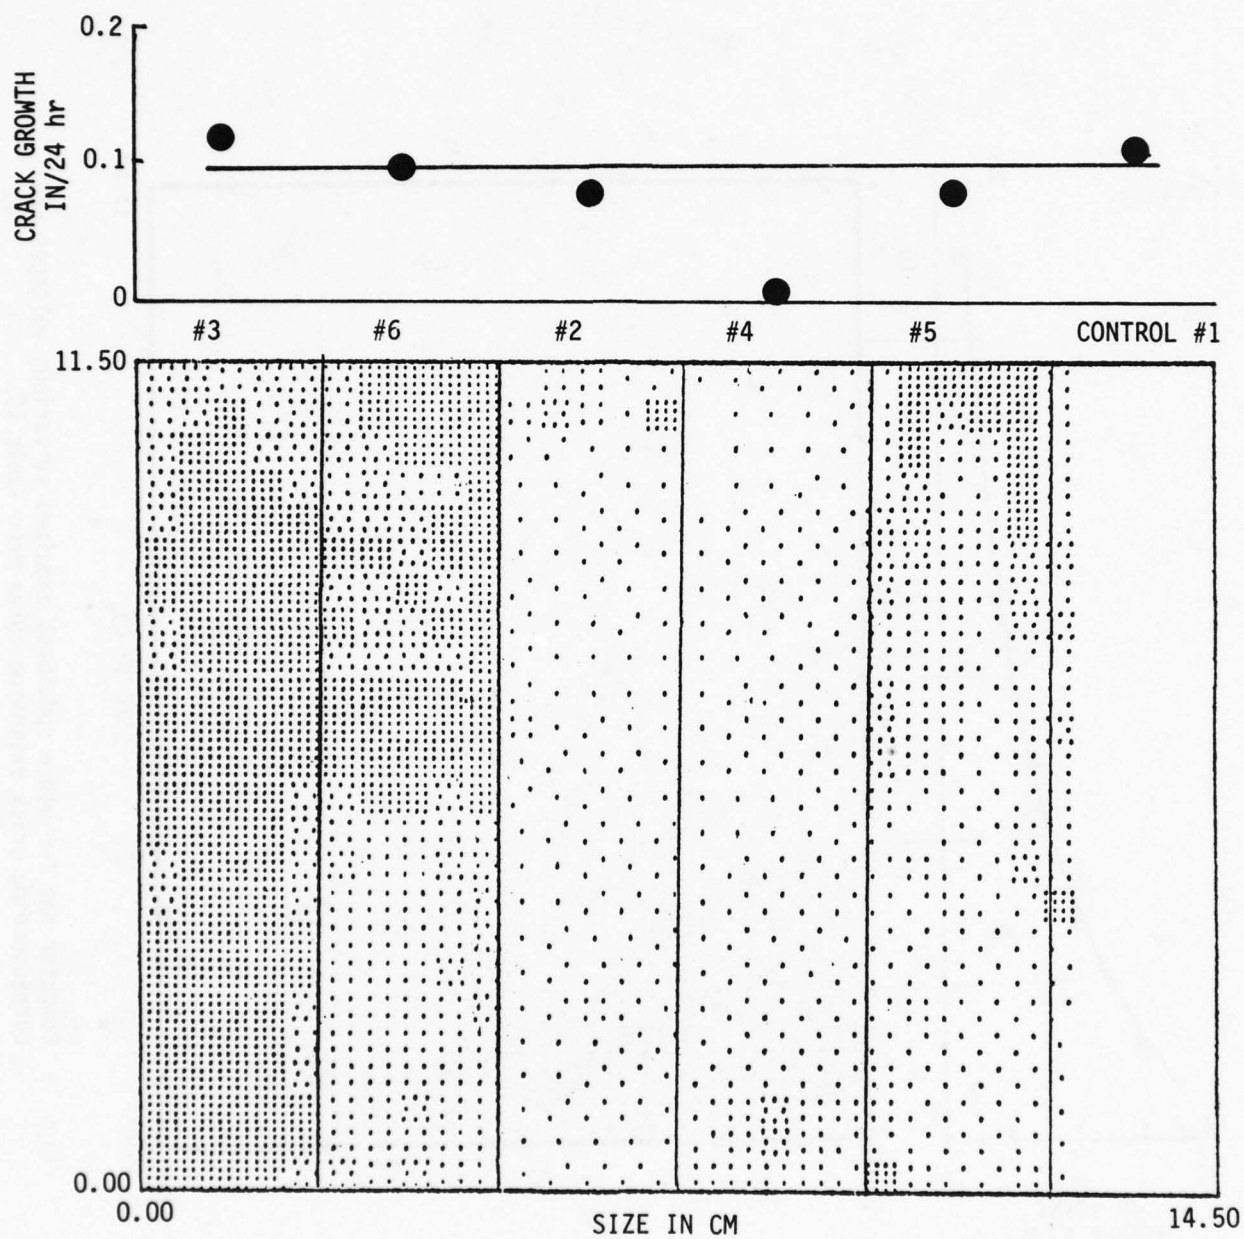
Fig. 20 Computer map of oil contaminated PAA wedge specimens and corresponding crack extension curve from Table 21.
